APPENDIX C

CCTV Data Logs

Project Summary

Project Name:		Lynn Water - Sewer Commission CCTV WE 10-12-18						
US MH	DS MH	Pipe ID	Date	Street	Material	Size	Total	Insp
MH18896	MH18926	MH-18896_MH-18926	10/9/2018	Centre Street	Vitrified Clay Pipe	8	471	471

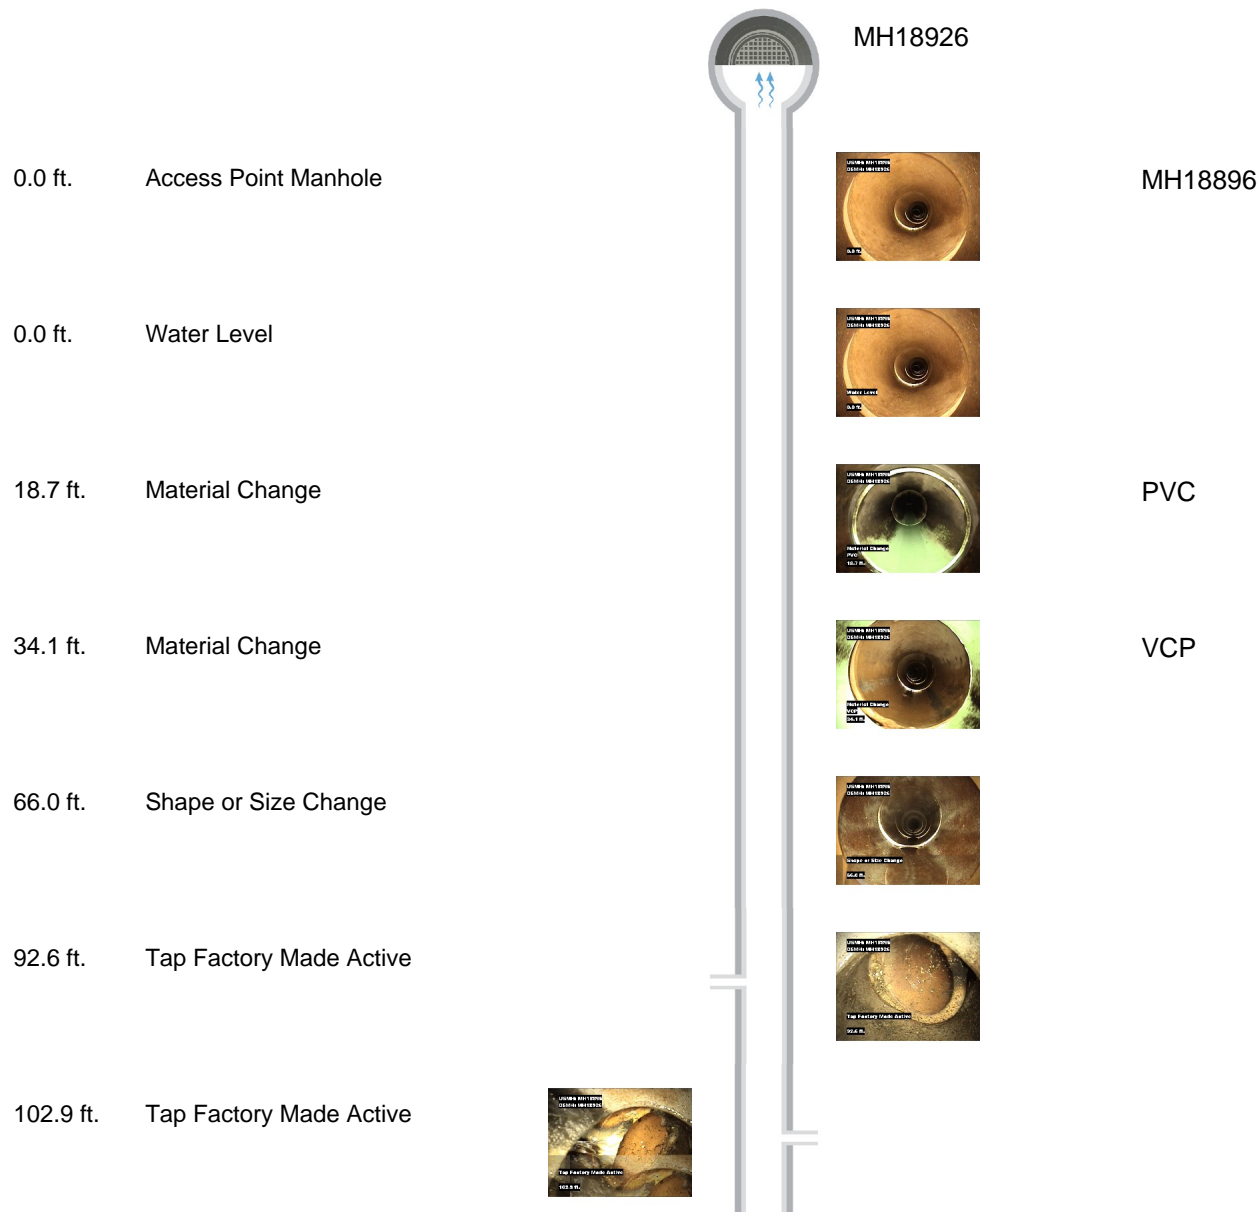
Defect Listing Plot with Images

Pipe Segment Refere...	City	Street	Material	Location C...	Sewer Use
MH-18896_MH-18926	Lynn- Ma	Centre Street	Vitrified Clay Pipe	Light High...	Sanitary
Upstream MH	Total Length	Year Laid	Shape	Location Details	
MH18896	471		Circular		
DS Manhole	Length surveyed	Year Renewed	Height	Width	Pipe Joint...
MH18926	471		8	8	
SPR 4	MPR 2	PO Number		Customer	
SPRI 4	MPRI 2			Stantec	
QSR 4100	QMR 2100	Work Order		Purpose	
				Maintenance Related	
OPR 6	Surveyed By	Direction	Date	Media label	
	Chris_M	Upstream	20181009	10-9-18	
OPRI 3	Certificate Number	Pre-Cleaning	Time	Weather	
	10-08-7625	Heavy Cleaning	09:41	Dry	
Date Cleaned			End Time	Additional Info	
20181009			10:26

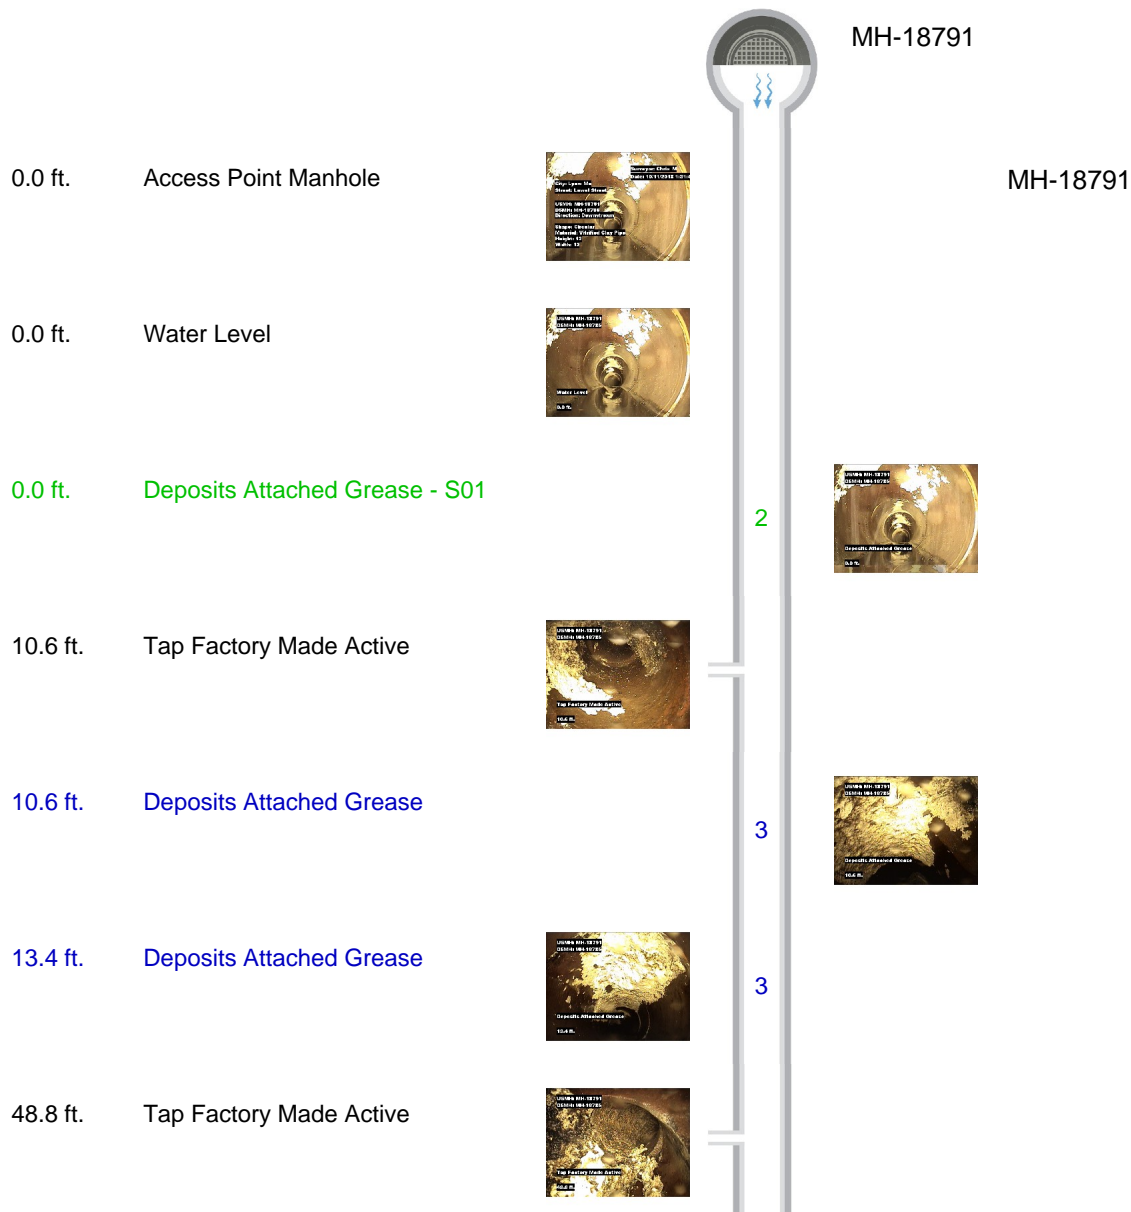
Defect Listing Plot with Images

Pipe Segment Refere... MH-18791_MH-18786	City Lynn- Ma	Street Lowel Street	Material Vitrified Clay Pipe	Location C... Light High...	Sewer Use Combined
Upstream MH MH-18791	Total Length 159	Year Laid	Shape Circular	Location Details	
DS Manhole MH-18786	Length surveyed 159	Year Renewed	Height 12	Width 12	Pipe Joint...
SPR 4	MPR 89	PO Number		Customer Stantec	
SPRI 2	MPRI 2.1	Work Order		Purpose Maintenance Related	
QSR 2200	QMR 5141				
OPR 93	Surveyed By Chris_M	Direction Downstream	Date 20181011	Media label 10-11-18	
OPRI 2.1	Certificate Number 10-08-7625	Pre-Cleaning Jetting	Time 13:32	Weather Damp	
Date Cleaned 20181011			End Time 13:53	Additional Info

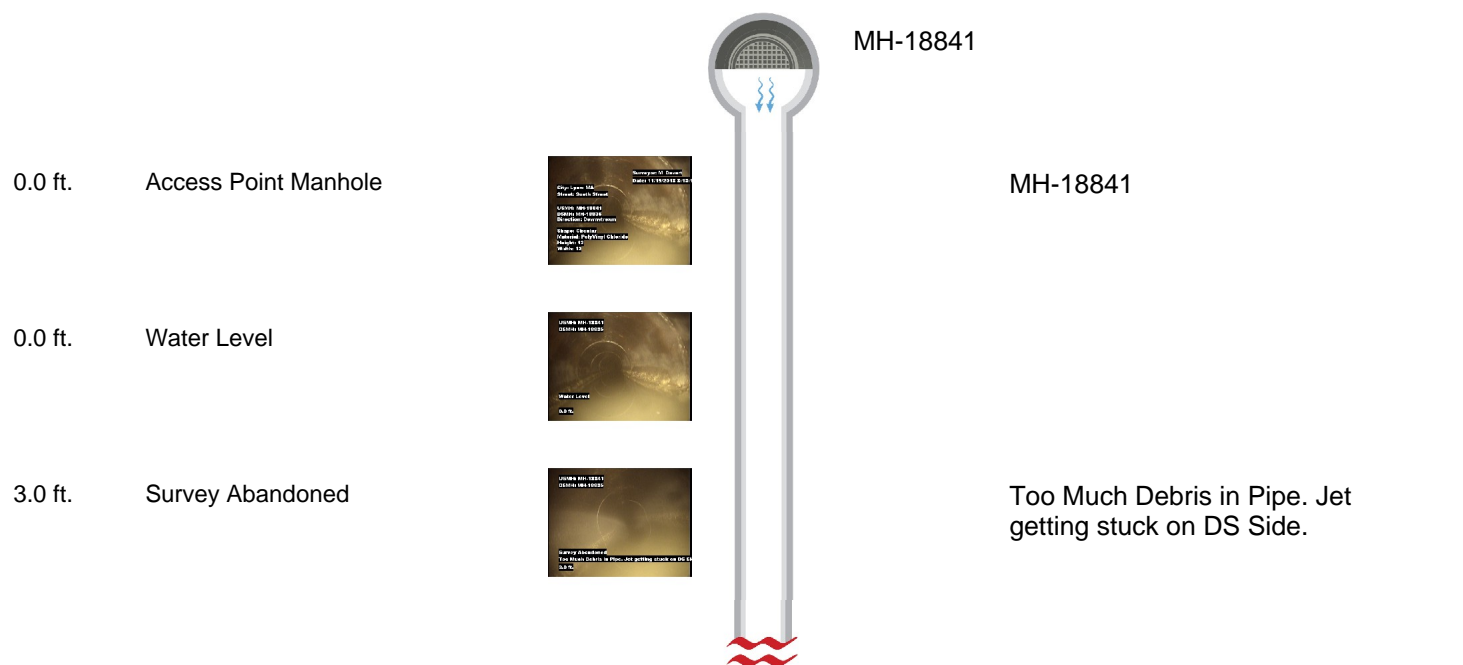
Defect Listing Plot with Images

Pipe Segment Refere...	City	Street	Material	Location C...	Sewer Use
MH-18841_MH-18836	Lynn- MA	South Street	PolyVinyl Chloride	Light High...	Combined
Upstream MH	Total Length	Year Laid	Shape	Location Details	
MH-18841			Circular		
DS Manhole	Length surveyed	Year Renewed	Height	Width	Pipe Joint...
MH-18836	3		12	12	
SPR	N/A	MPR	N/A	PO Number	
SPRI	N/A	MPRI	N/A	Customer	
QSR	N/A	QMR	N/A	Work Order	
OPR	N/A	OPRI	N/A	Purpose	
OPRI	N/A	OPRI	N/A	Maintenance Related	
OPR	N/A	OPRI	N/A	Media label	
OPRI	N/A	OPRI	N/A	Weather	
OPRI	N/A	OPRI	N/A	Light Rain	
OPRI	N/A	OPRI	N/A	Additional Info	
OPRI	N/A	OPRI	N/A	End Time	
OPRI	N/A	OPRI	N/A	08:35

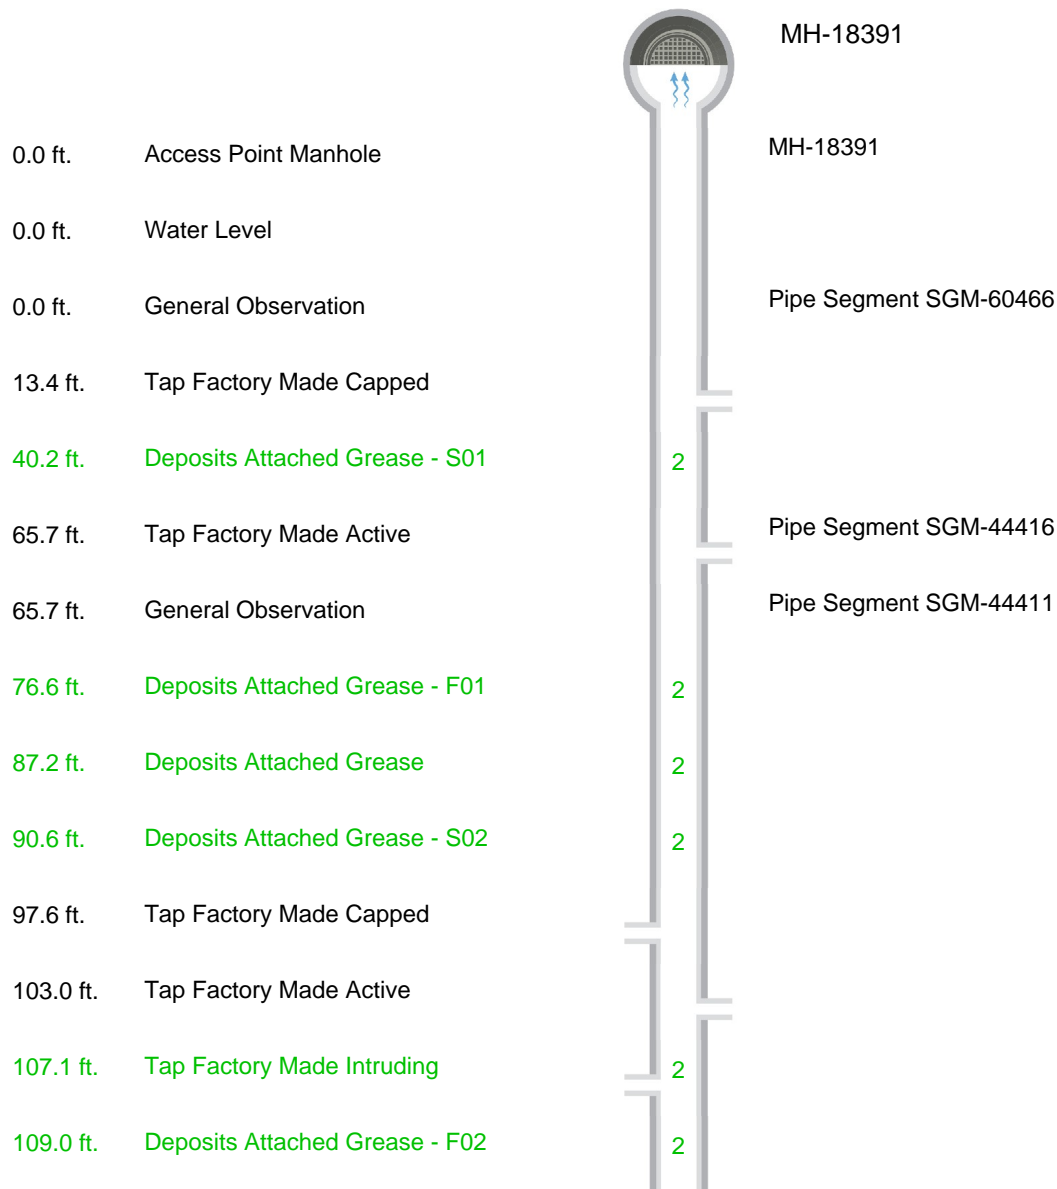
Defect Listing Plot

Pipe Segment Refere... MH-18391_End East	City Lynn	Street Summer Street	Material Vitrified Clay Pipe	Location C... Light High...	Sewer Use Combined
Upstream MH End East	Total Length 220	Year Laid	Shape Circular	Location Details	
DS Manhole MH-18391	Length surveyed 109	Year Renewed	Height 8	Width 8	Pipe Joint...
SPR 0	MPR 26	PO Number		Customer Stantec	
SPRI 0	MPRI 2	Work Order		Purpose Maintenance Related	
QSR 0000	QMR 2A00				
OPR 26	Surveyed By Chris_M	Direction Upstream	Date 20181011	Media label 10-11-18	
OPRI 2	Certificate Number 10-08-7625	Pre-Cleaning Jetting	Time 12:17	Weather Damp	
Date Cleaned 20181011			End Time 12:34	Additional Info

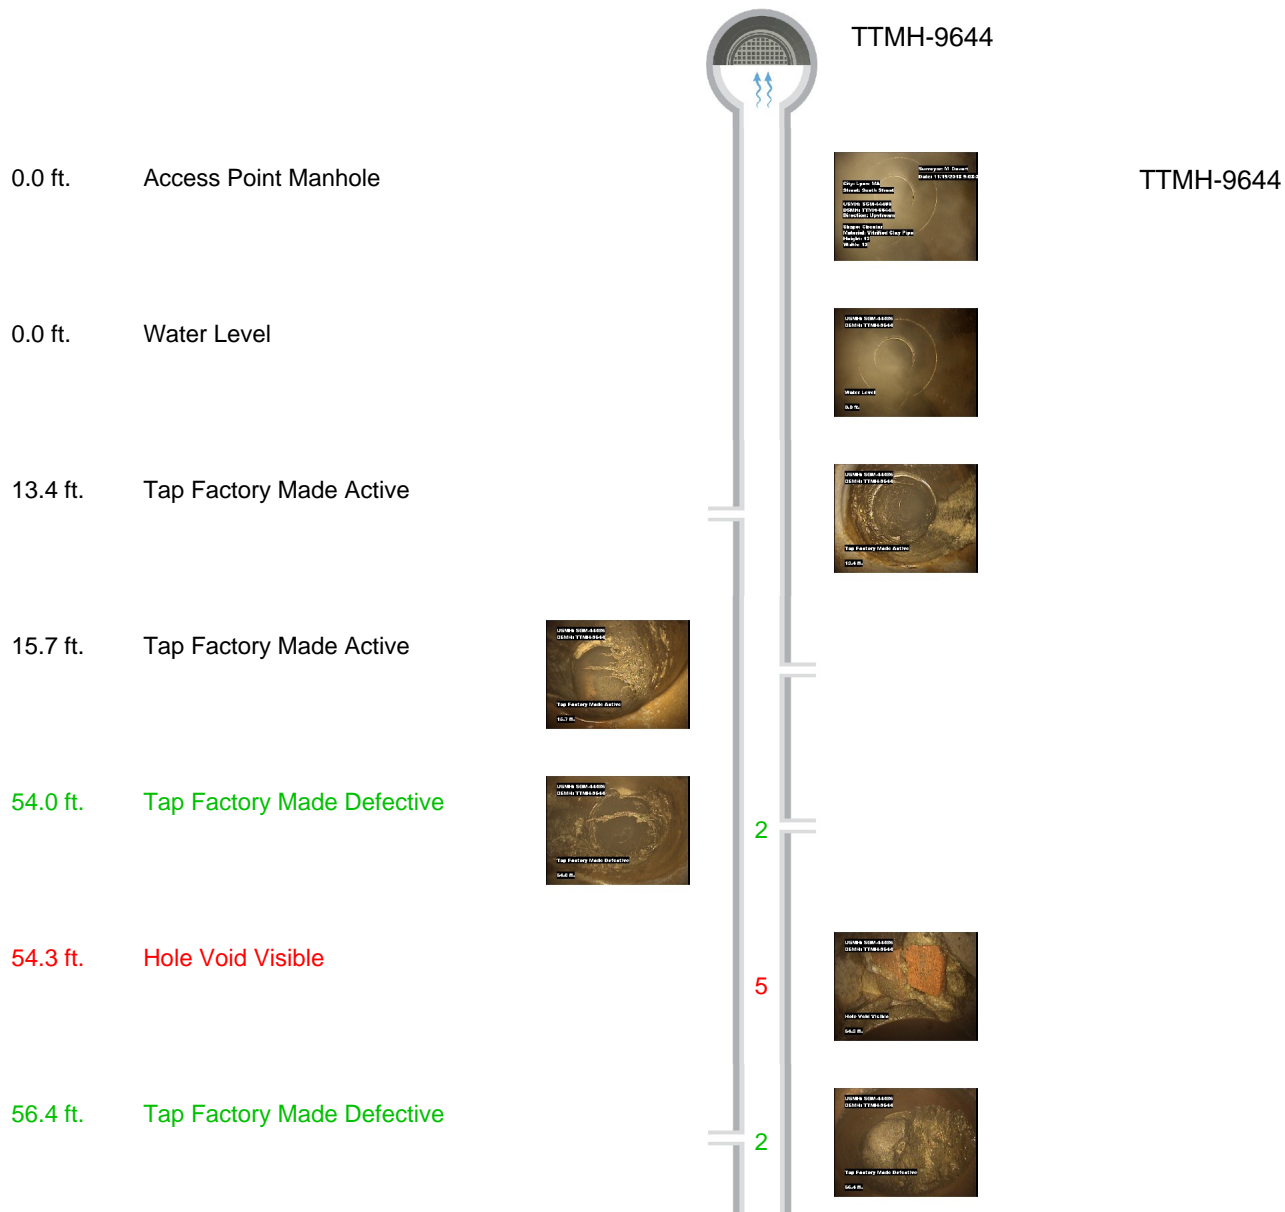
Defect Listing Plot with Images

Pipe Segment Refere...	City	Street	Material	Location C...	Sewer Use
TTMH-9644_SGM-44486	Lynn- MA	Western Avenue	Vitrified Clay Pipe	Light High...	Combined
Upstream MH	Total Length	Year Laid	Shape	Location Details	
SGM-44486	260		Circular		
DS Manhole	Length surveyed	Year Renewed	Height	Width	Pipe Joint...
TTMH-9644	155		12	12	
SPR 19	MPR 6	PO Number		Customer	
SPRI 3.2	MPRI 2			Stantec	
QSR 5241	QMR 2300	Work Order		Purpose	
				Maintenance Related	
OPR 25	Surveyed By	Direction	Date	Media label	
	M_Davert	Upstream	20181119	11-19-18	
OPRI 2.8	Certificate Number	Pre-Cleaning	Time	Weather	
	07003881	Heavy Cleaning	09:34	Light Rain	
Date Cleaned			End Time	Additional Info	
20181119			09:48

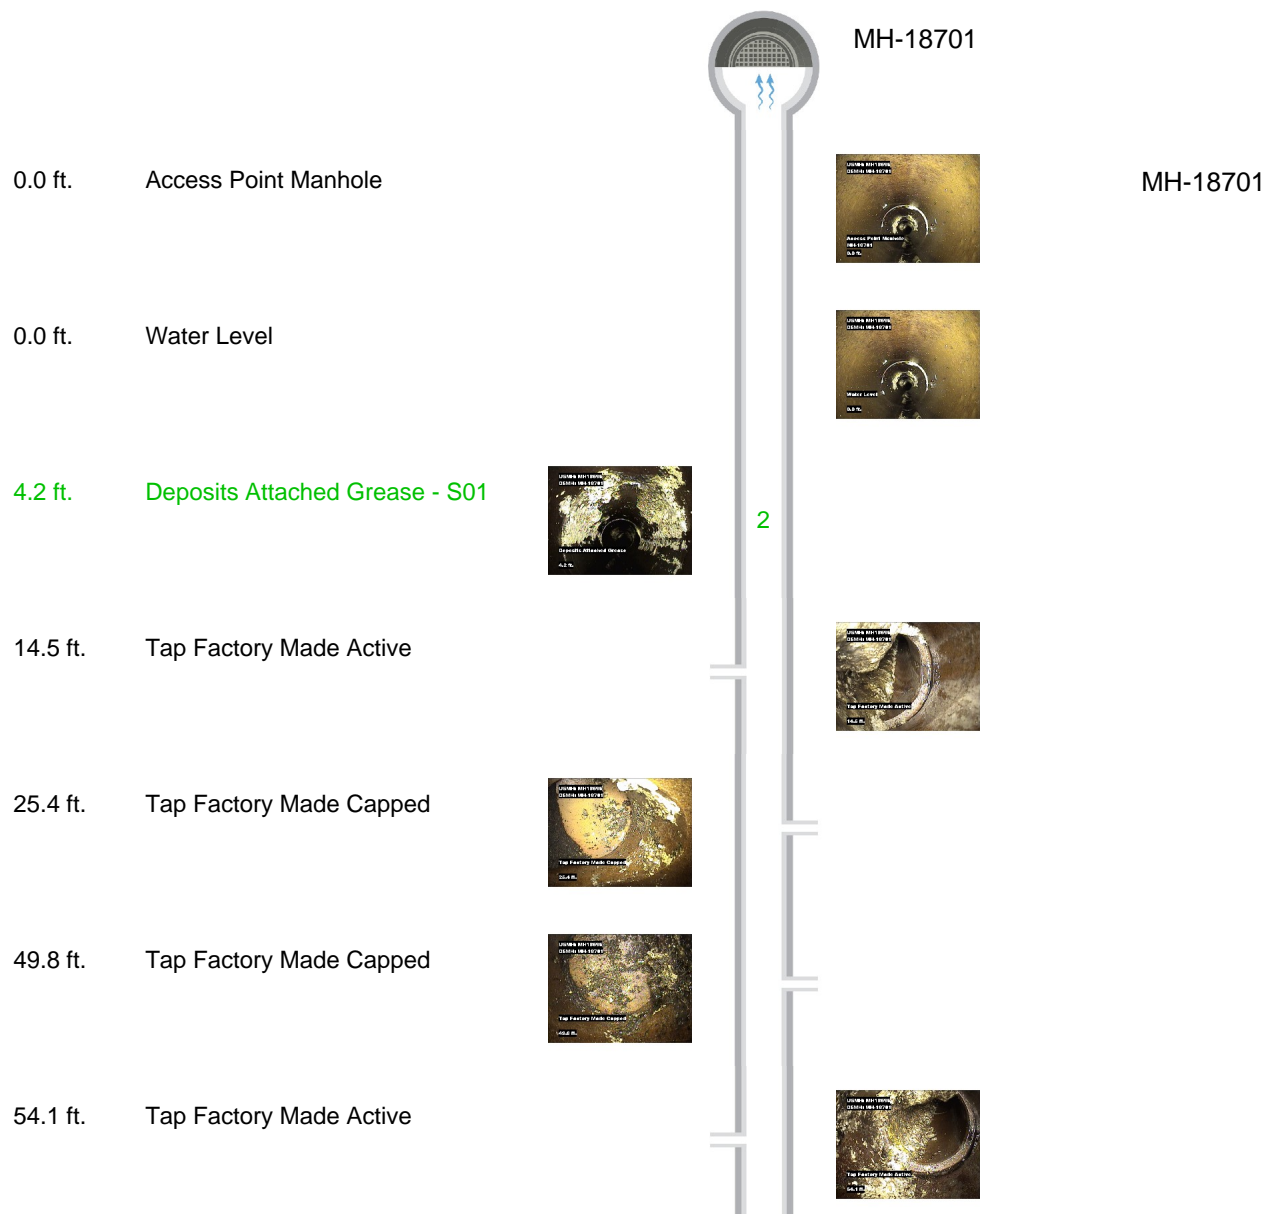
Defect Listing Plot with Images

Pipe Segment Refere... MH-18701_MH18696	City Lynn- Ma	Street Witt Street	Material Vitrified Clay Pipe	Location C... Light High...	Sewer Use Combined
Upstream MH MH18696	Total Length 124	Year Laid	Shape Circular	Location Details	
DS Manhole MH-18701	Length surveyed 124	Year Renewed	Height 8	Width 8	Pipe Joint...
SPR 5	MPR 42	PO Number		Customer Stantec	
SPRI 5	MPRI 2	Work Order		Purpose Maintenance Related	
QSR 5100	QMR 2C00				
OPR 47	Surveyed By Chris_M	Direction Upstream	Date 20181011	Media label 10-11-18	
OPRI 2.1	Certificate Number 10-08-7625	Pre-Cleaning Jetting	Time 10:15	Weather Damp	
Date Cleaned 20181011			End Time 10:23	Additional Info
